BUILDING SURVEY REPORT

Property:

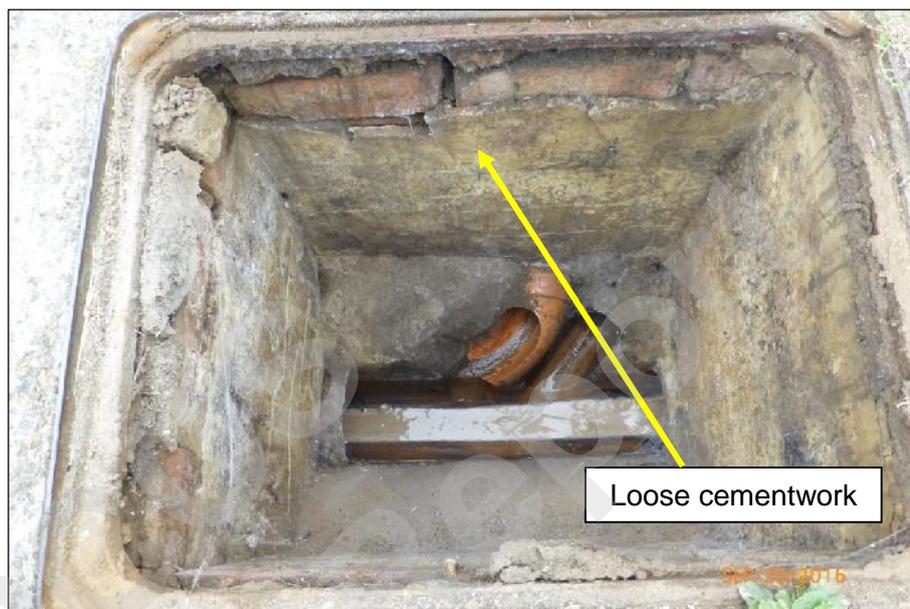
Outside, two inspection chambers were located in the side driveway to which the covers were lifted revealing the channels to be free flowing at these points. Some of the cement lining the walls of the front chamber is cracked and loose and could fall into the drains and cause a blockage (see photo below). You should arrange to have this repaired soon. Since October 2011, shared drains are the responsibility of the local sewerage company so they should be contacted and informed of the problem.

Brickwork forming the gully surround by the front corner of the house is in poor condition and the grille over the gully is broken. You should have these repaired soon.

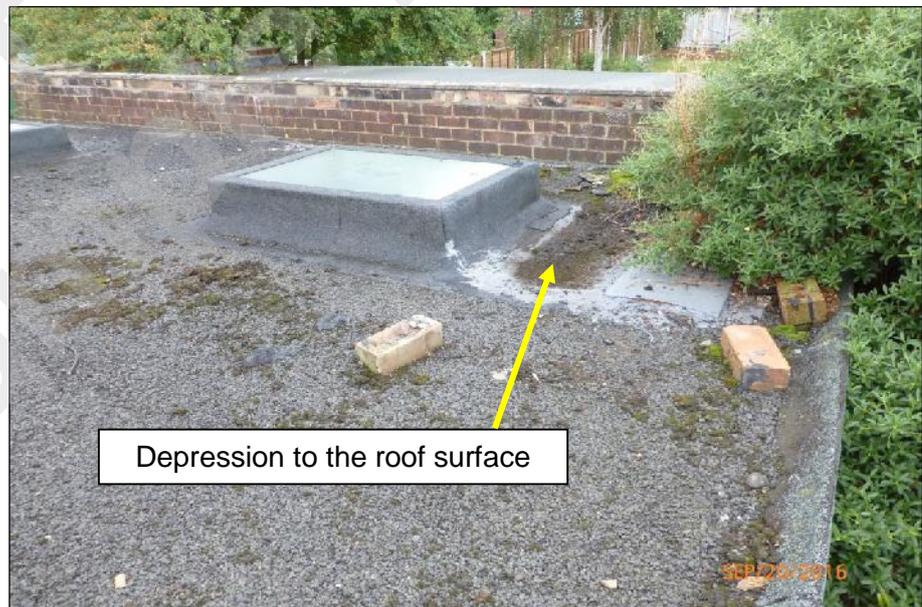
There have been water leaks through the flat roof, affecting the rear-left corner and around the right-hand roof light. There was no sign of current dampness and recent water ingress indicating the leaks have been repaired and there is evidence of this on the surface of the roof. However, the roof is sunken around the roof lights (particularly around the right-hand one) and the dips will hold rainwater which will be prevented from flowing to the gutter (see photo below).

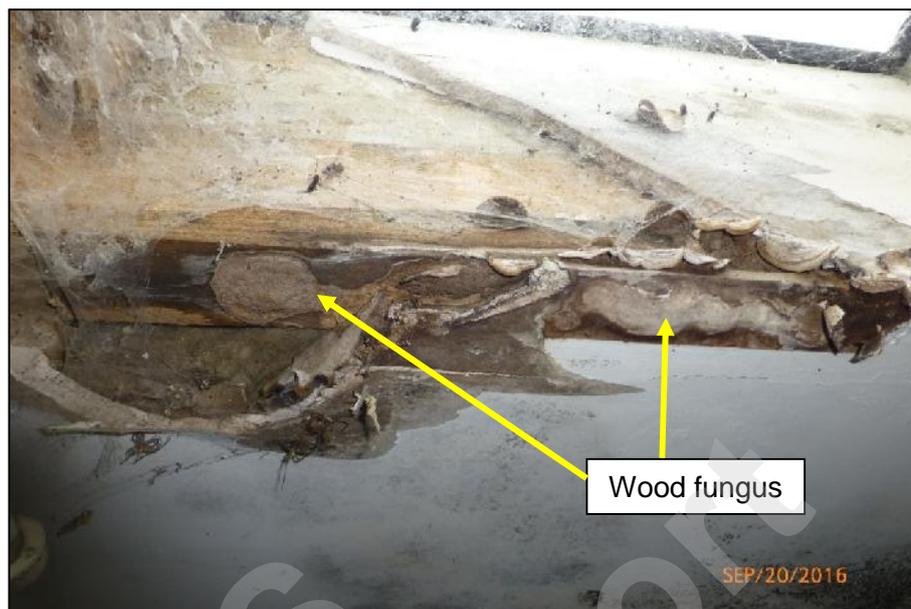
The roof is in need of repair and this is likely to involve replacing some of the concealed timberwork. Although there does not look to be a current leak, fungus growing on the exposed section of the joist under the right-hand roof light (visible inside the garage, see photo below) indicates a need for further investigation and repair to the roof structure in this area.

Until the roof structure is opened up and examined, it is difficult to know the extent of repairs required. Ultimately, it may be cost-effective or necessary to replace a substantial part of the roof and to fully renew the felt covering. If localised repairs are made, you should appreciate that the felt roof covering is of a type to have limited life and will be prone to sudden failure, and that it will need periodic repair and eventual replacement.
